# CONSTRUCTION STORMWATER GENERAL PERMIT INSPECTION REPORT

State of Washington Department of Ecology

The Electron Hydro LLC Intake project is covered under the State of Washington's Construction Stormwater General Permit (CSWGP). The CSWGP is a National Pollutant Discharge Elimination System (NPDES) and a State Waste Discharge permit for discharge of construction-related stormwater. Carol Serdar had previously been to the site a few years' prior, during the JARPA review for the then proposed re-construction of the barrier dam and intake structure and on 11 August 2020 in response to ERTS699710.

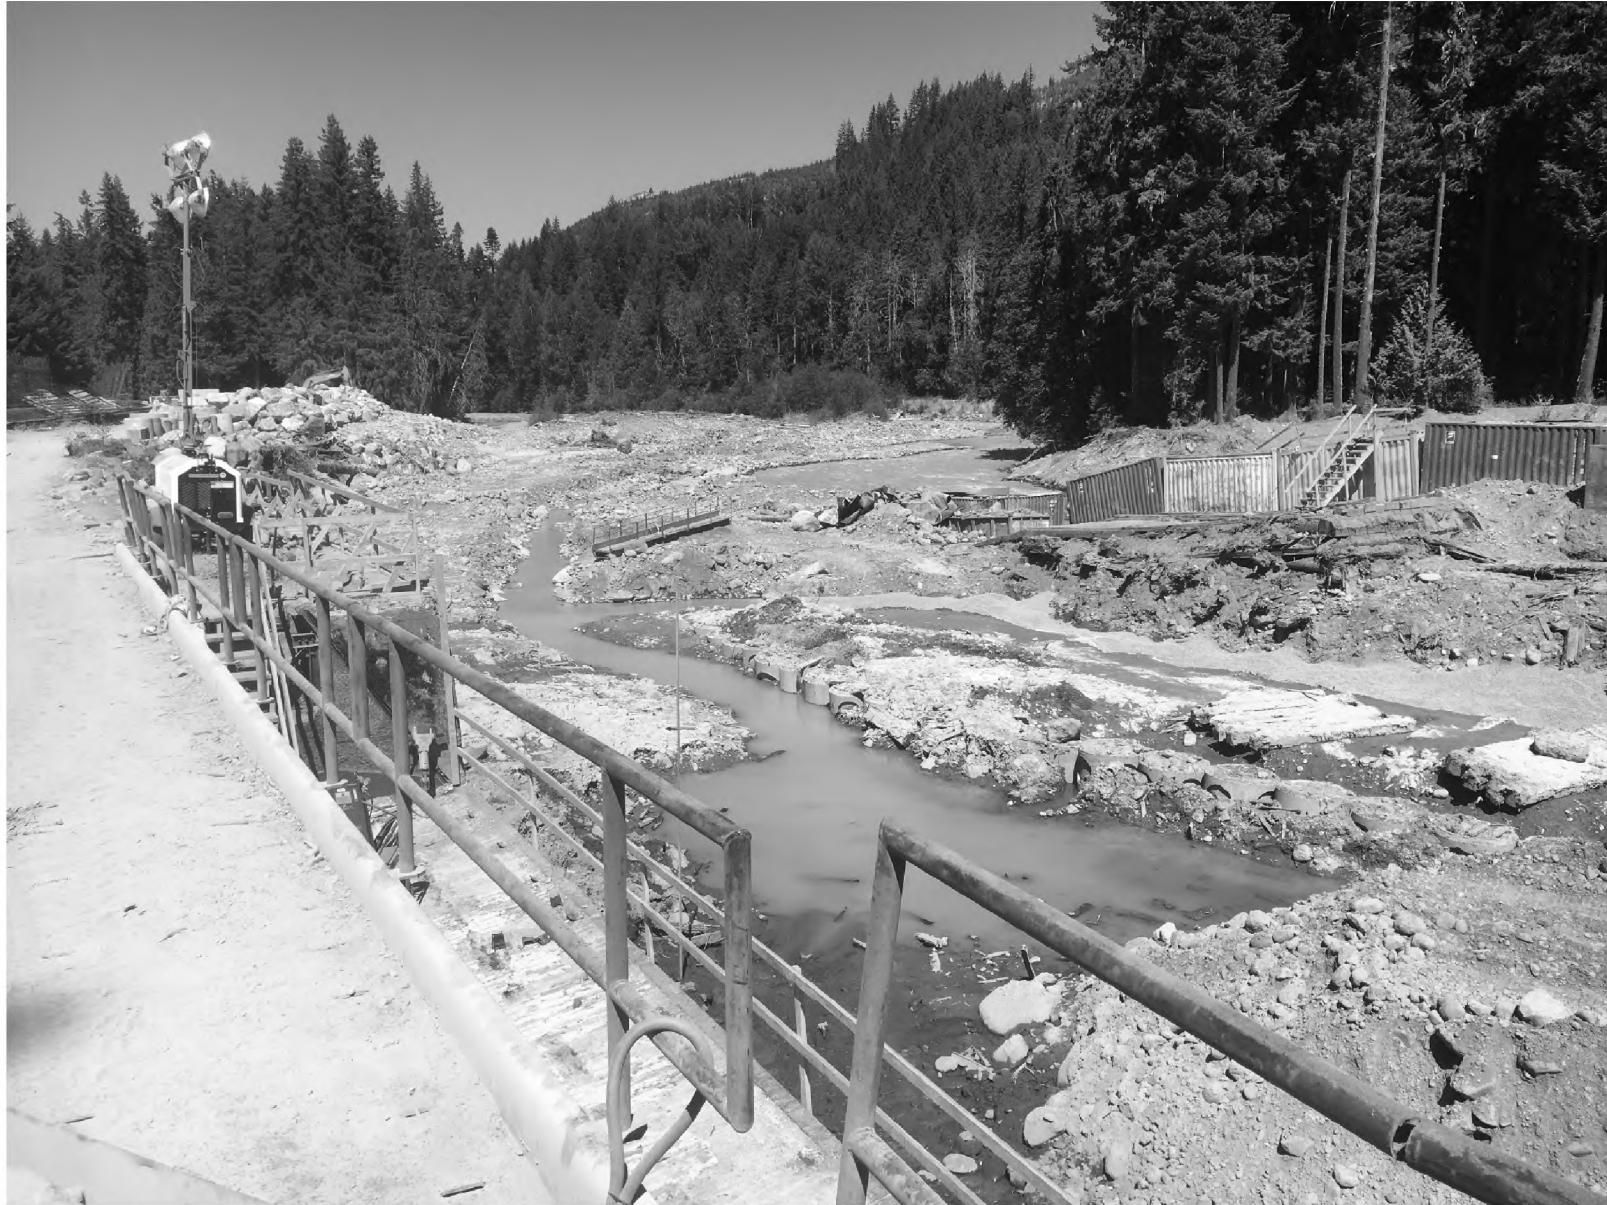
**Photo 2**

Walked same direction as on 11 August 2020; beginning above the intake structure. Discussed exposed slope management. Exposed and unworked soil is **a violation of CSWGP condition S9.D.5.d.** This area may be a challenge to temporarily stabilize based on proximity to active riverbed construction.

Photo Description: Parked adjacent to intake structure; discussed upland CSWGP area and BMPs to stabilize exposed and unworked soil.

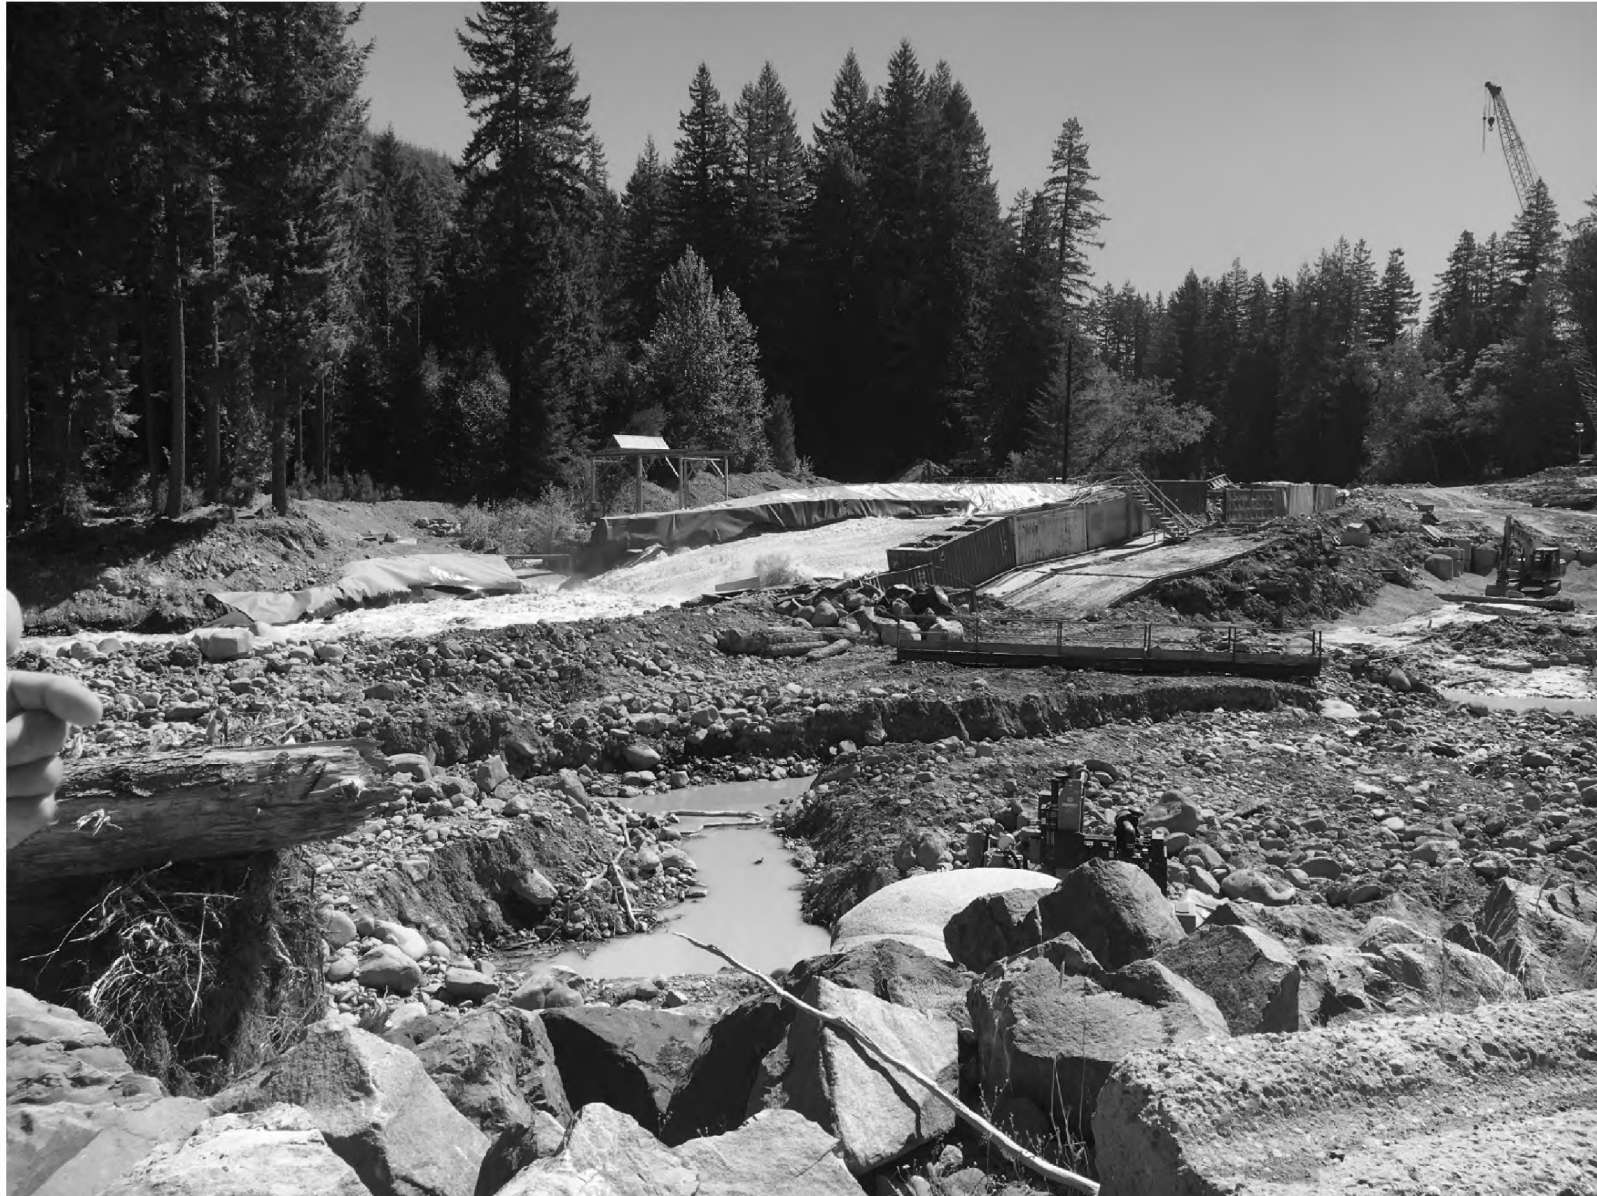
**Photo 4**

Photo Description: Portion of sports turf under black liner was ripped away during headward erosion of streambed at lower section of channelized river, at the downstream end of the fish ladder (fish ladder at black plastic gap on bank across river).

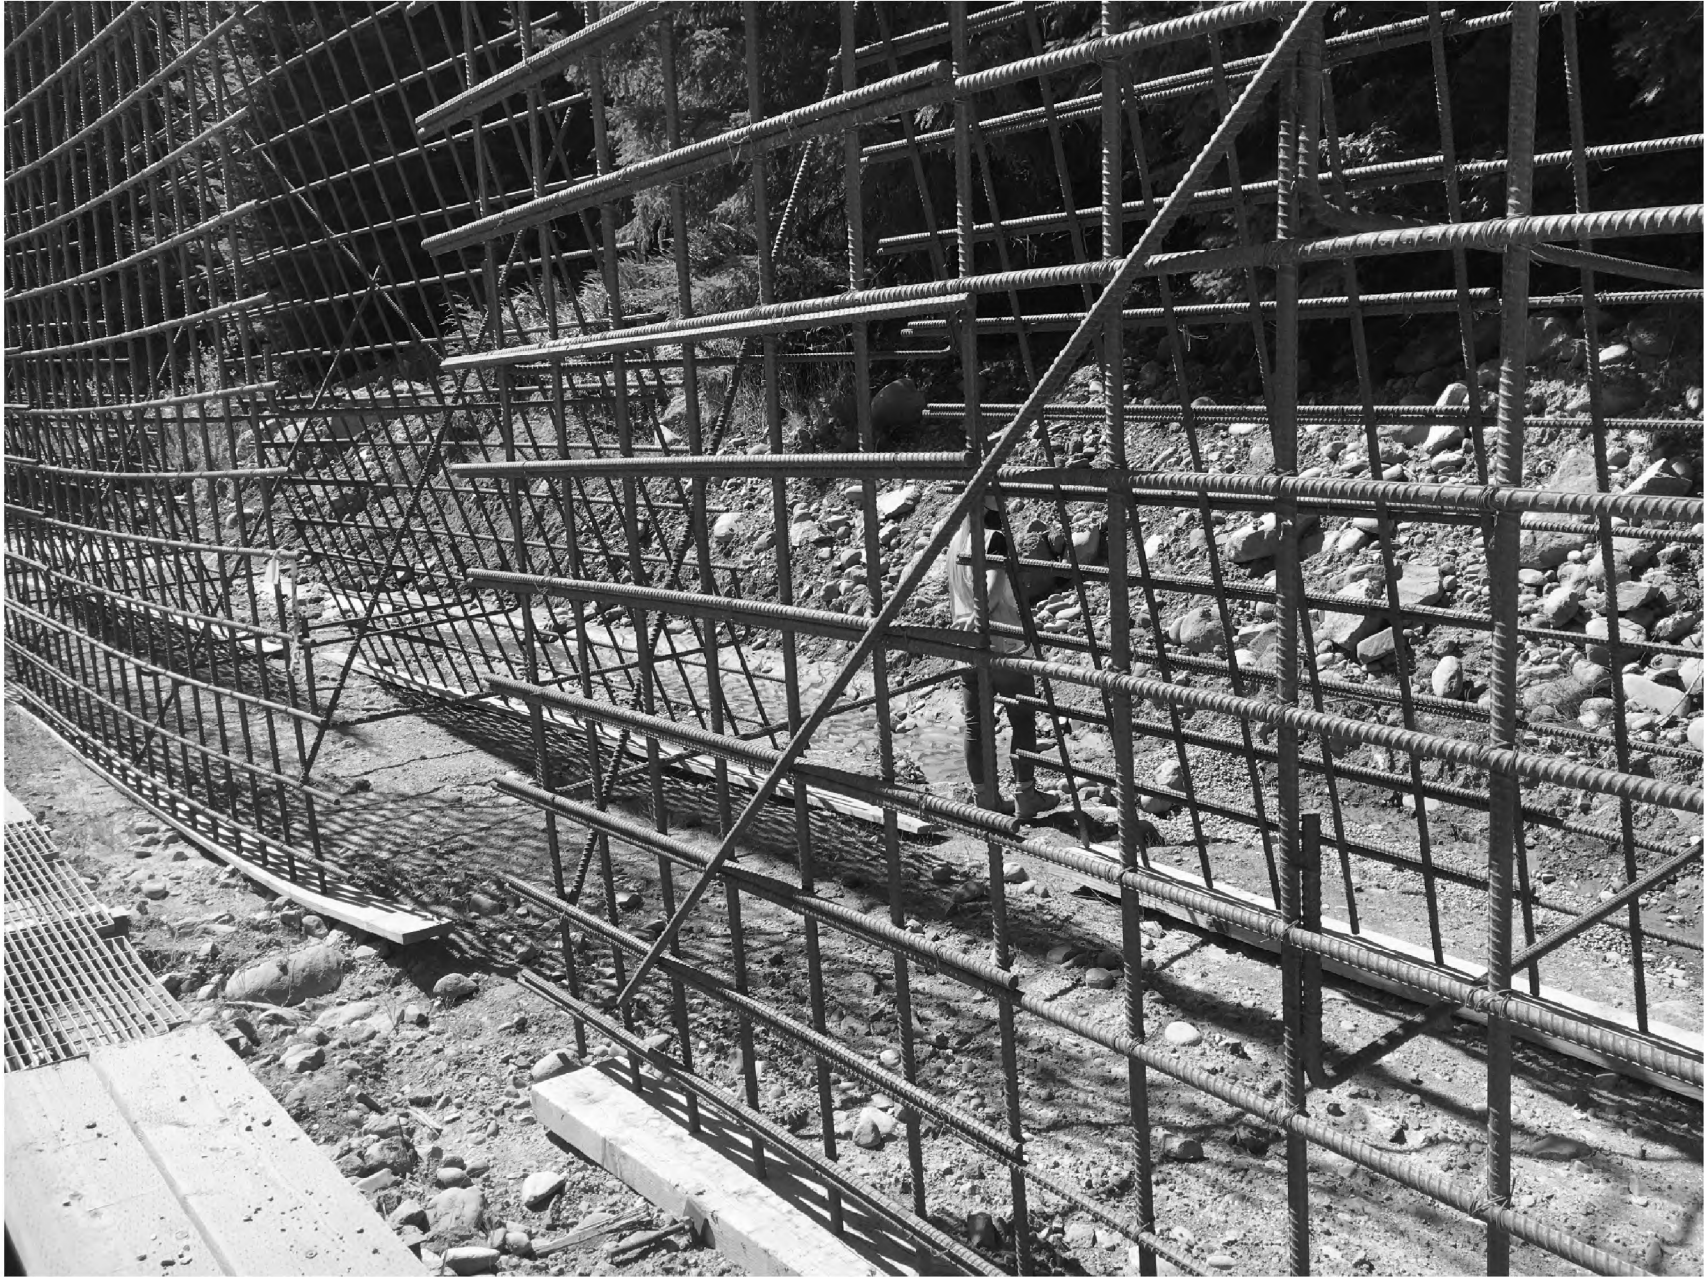
**Photo 5**

Stormwater management was explained; water from upland and dewatering water from the river construction area is comingled and enters the ditch between the base of the hillslope and the flume, comingled water flows into the sediment pond with the standpipe and rack on top, then into the stormwater ponds with three weirs (now constructed with siltfences, straw bales have been removed). Before discharge, water is sampled and if it is less than 110% of background sample, then the water may be discharged from the last stormwater pond into ditch with check dams to discharge into the Puyallup River. If water in the stormwater pond is greater than 110% of background sample, the water would be pumped from the stormwater pond to infiltrate into the adjacent forestland (visual monitoring would occur around the forested area)\*\*\*\*. The stormwater system needed maintenance as soon as possible for additional stormwater capacity (CSWGP condition S9.D.3. and S9.D.9.4.).

Photo Description: Stormwater and dewatering water are comingled in ditch between base of slope and reconstruction of flume; conveyance ditch flows into a Sediment Pond.

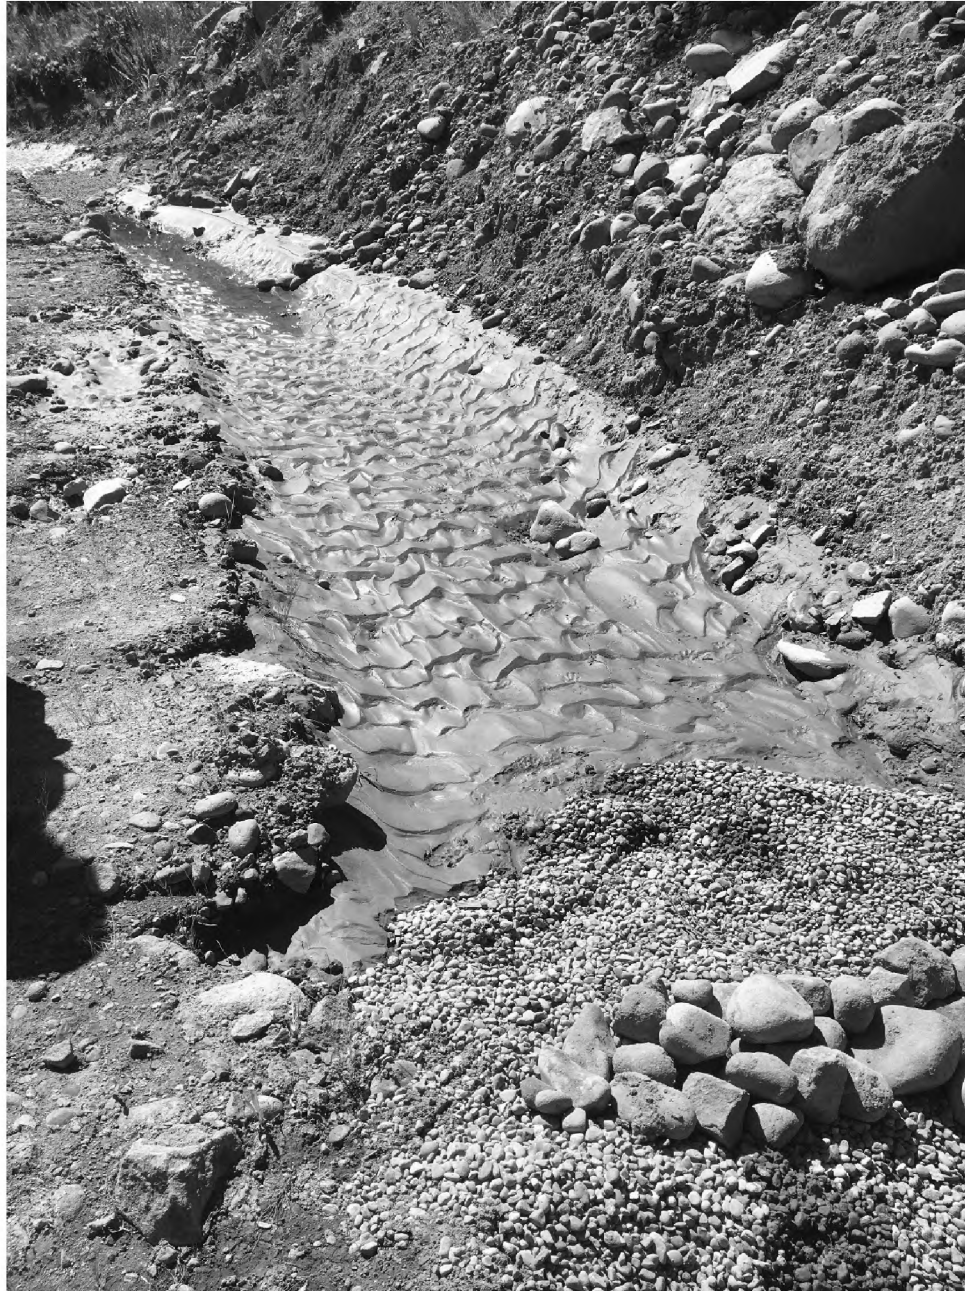
**Photo 6**

Photo Description: Conveyance Ditch contains fines from Puyallup River dewatering water; discussed appropriate ditch management and cleaning schedule as soon as possible.

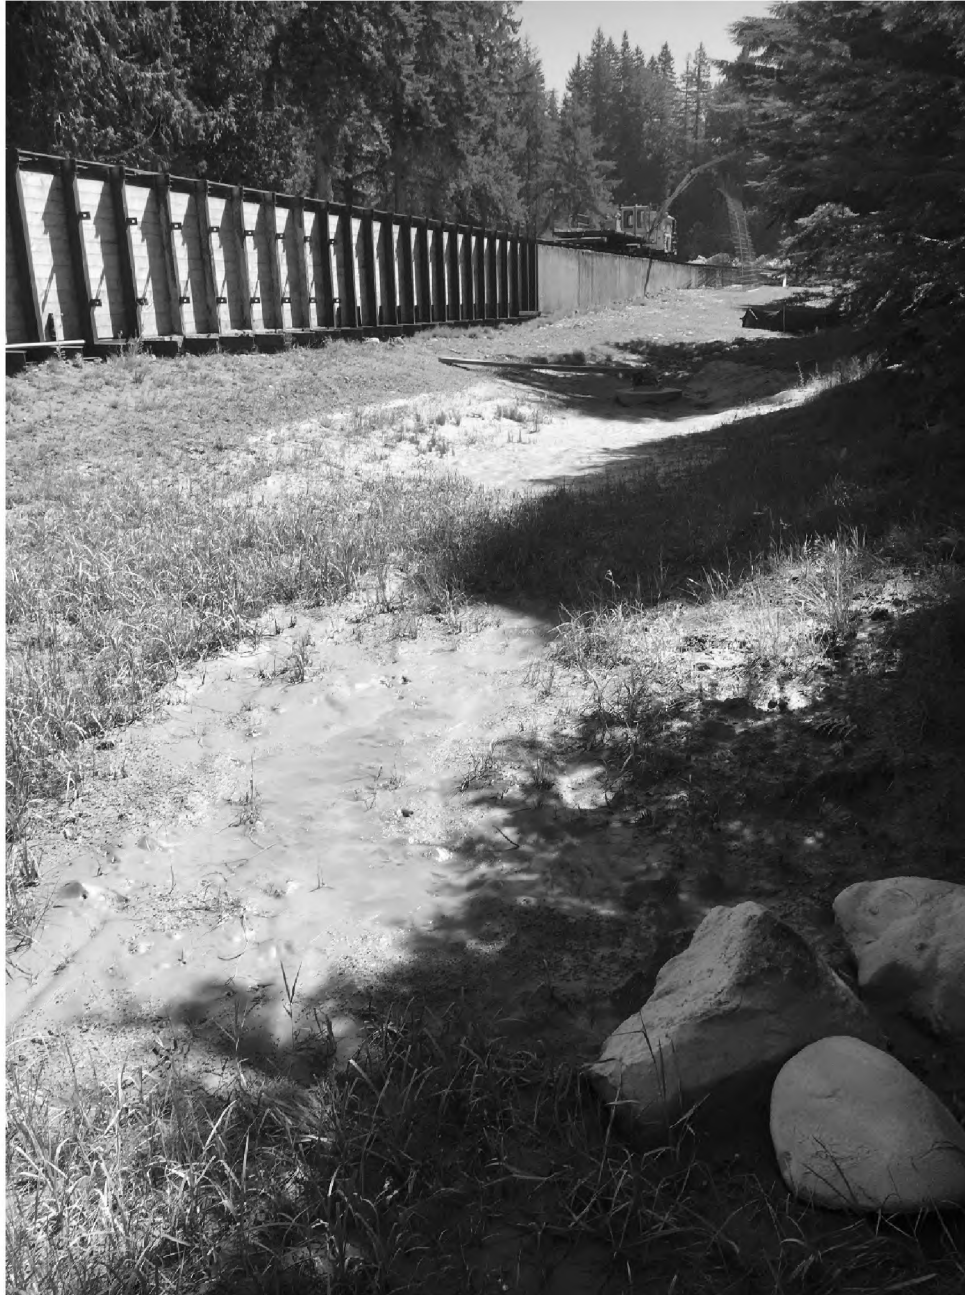
**Photo 7**

Photo Description: Sediment Pond has a standpipe and outlet structure (in shadow); discussed BMPs for additional settling out of fines and cleaning schedule.

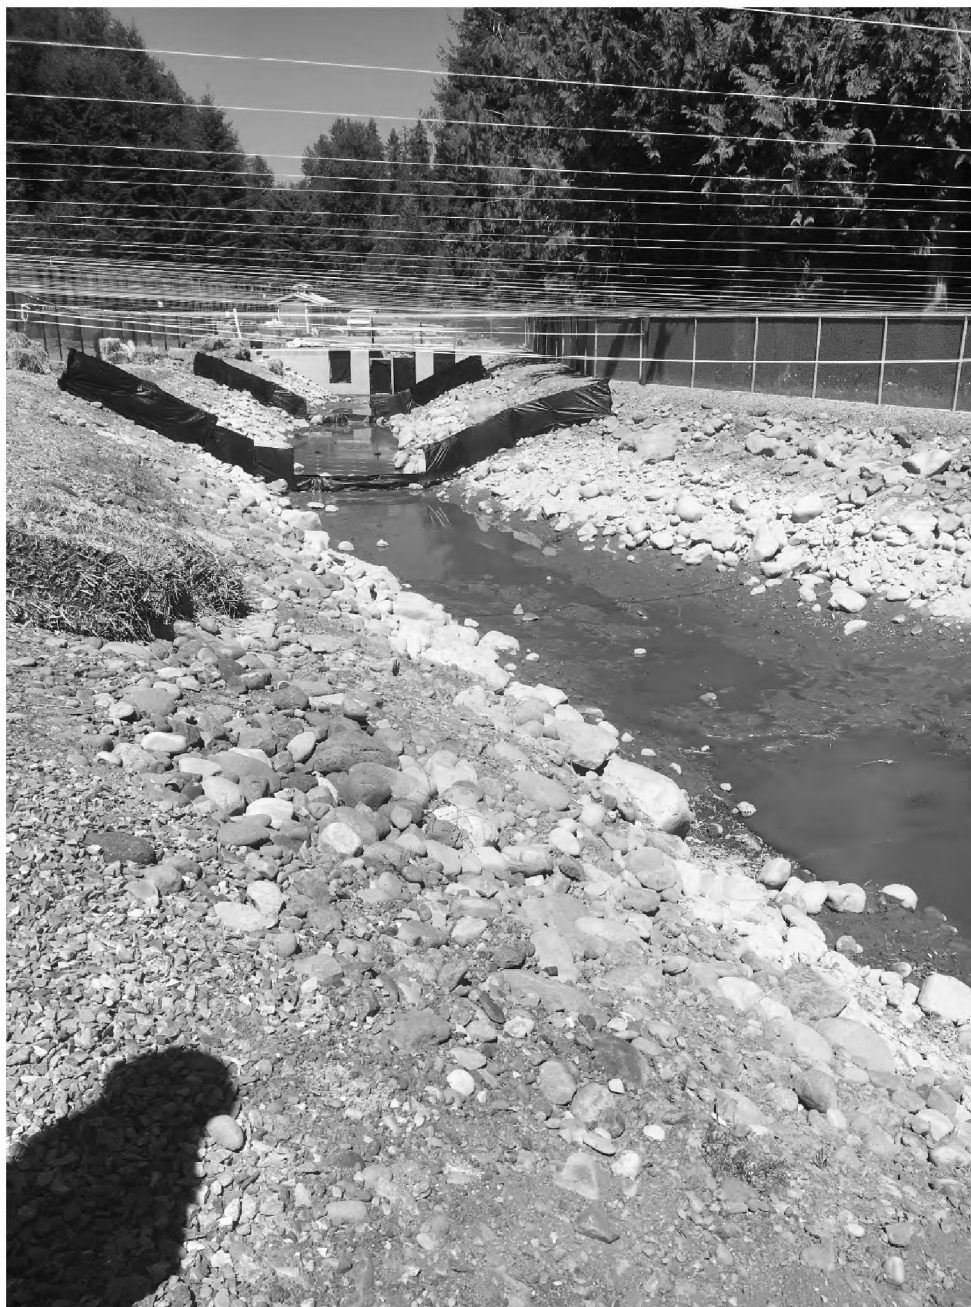
**Photo 8**

Photo Description: Stormwater pond with checkdams settle out additional fines before last ditch (at far end of pond); discussed cleaning schedule and ability to overflow into forest to right of pond if turbidity is 110% or greater than background water sample.
